**Dow Brook
Reservoir Dam
Improvements
2018-2019**

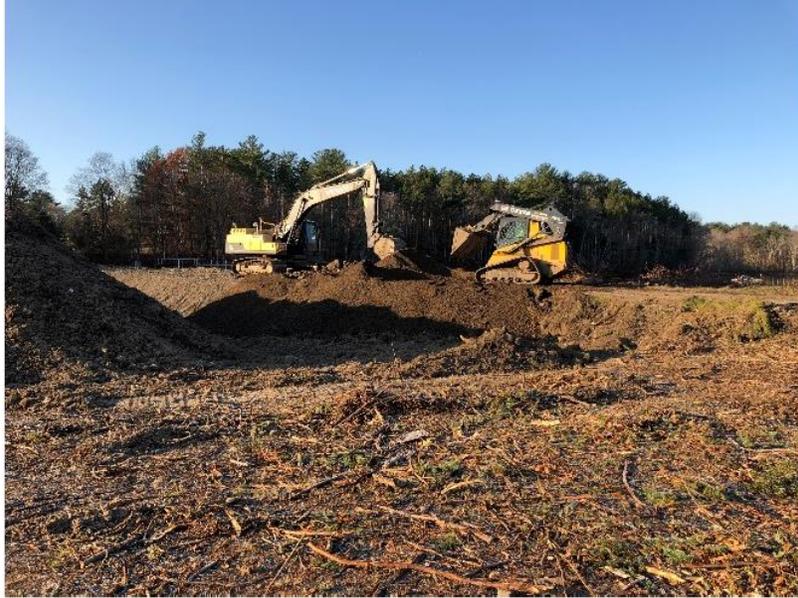
Photo 1
Placing imported processed 1-1/2 in. material for access road on dam crest

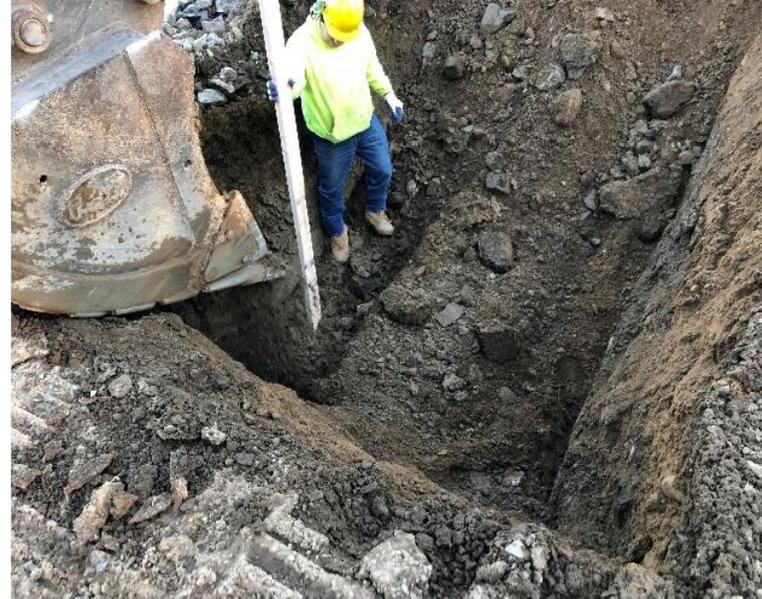
Photo 2
Test pit exposing existing stone block core wall

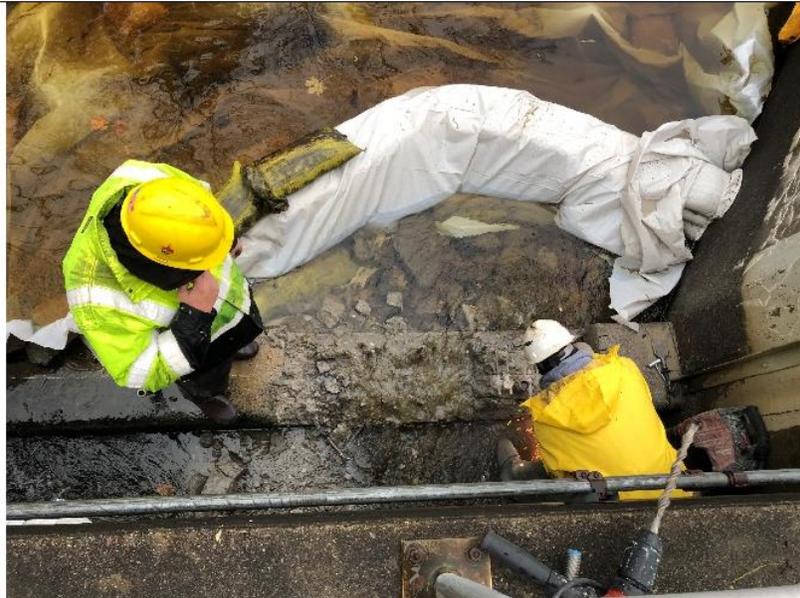
Photo 3
Demolition of the north side of concrete spillway from El. 31 to El. 30

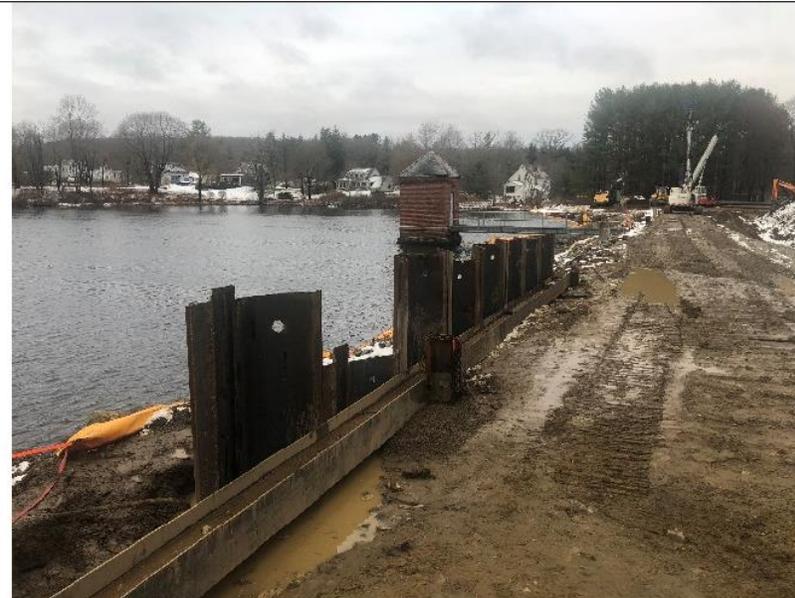
Photo 4
Installation of steel sheeting from STA 0+05 to STA 0+45

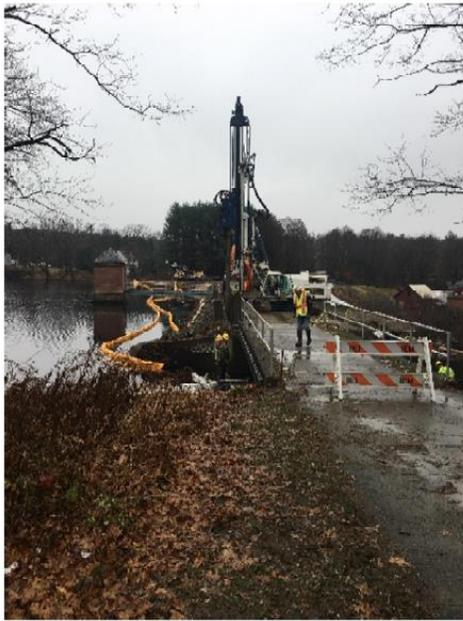
Photo 1
Installing sheeting south of gatehouse.

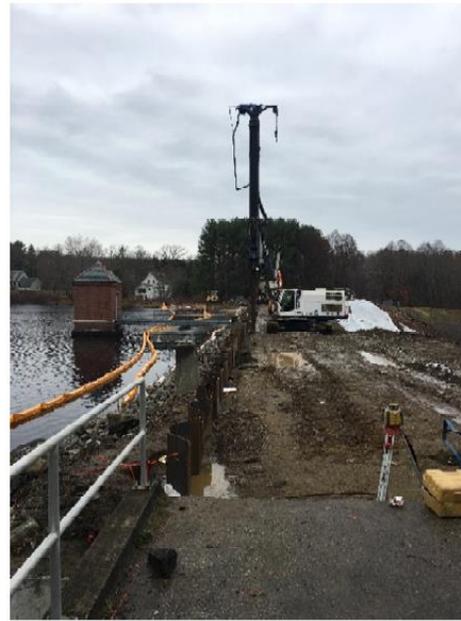
Photo 2
Removing H pile probe and guide.

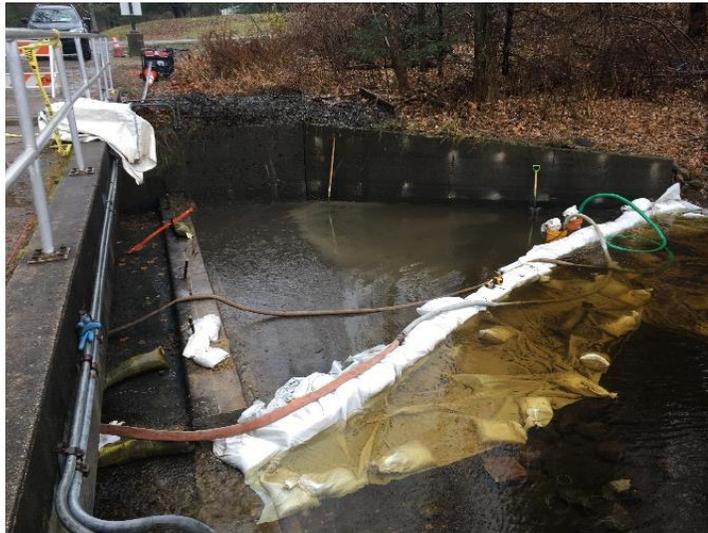
Photo 3
Cofferdam around southern wall and
drill holes completed.

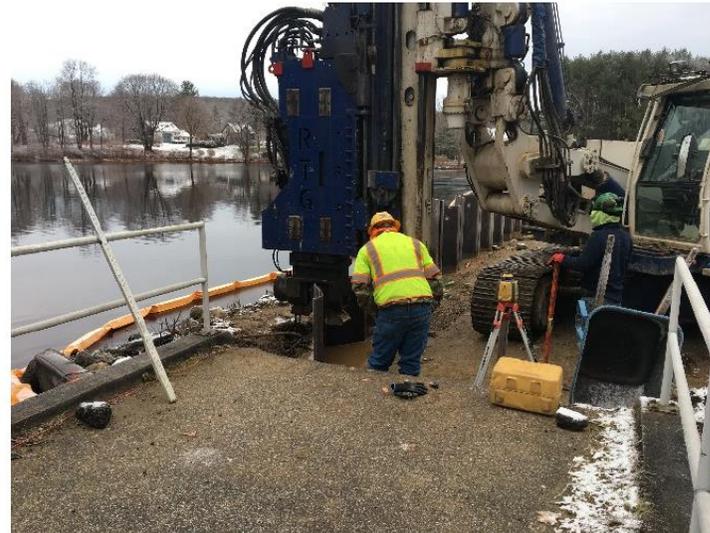
Photo 4
Surveying final top elevation of sheeting pair.

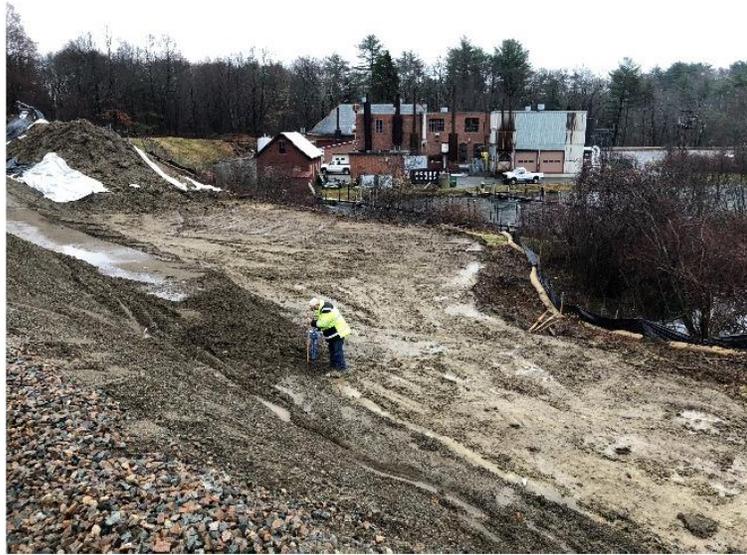
Photo 1
Water Department layout of existing water supply
and drain pipe

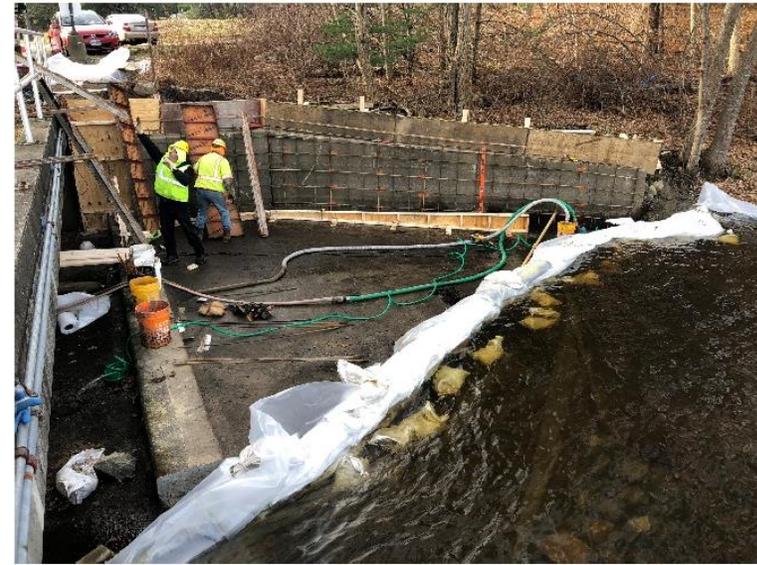
Photo 2
South spillway training wall prior to forming and
concrete placement with installed rebar

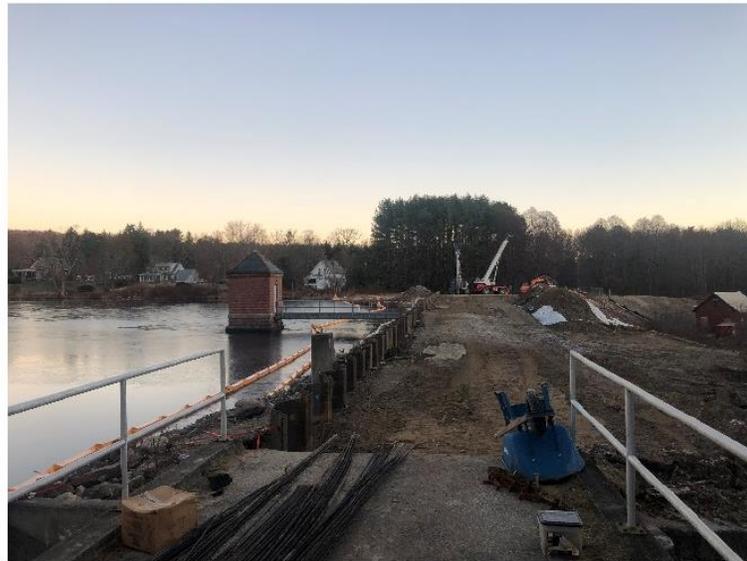
Photo 3
Completed steel sheet pile cutoff wall facing east

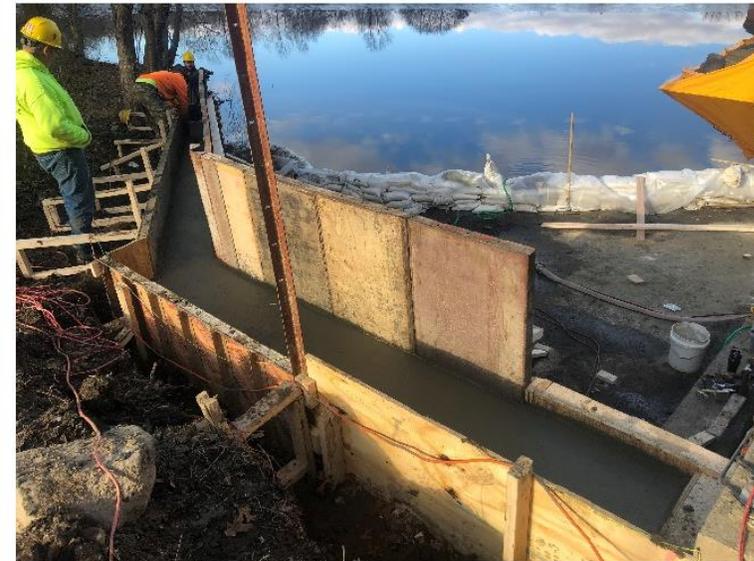
Photo 4
Completed concrete placement for south
Training abutment wall

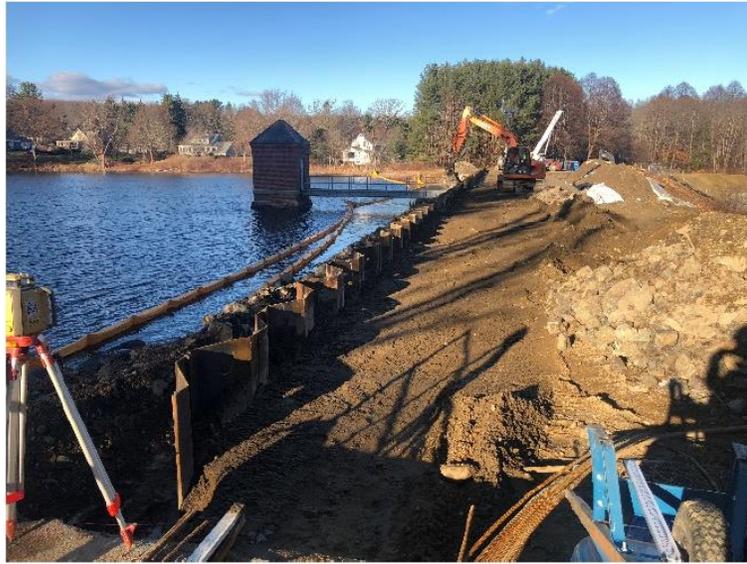
Photo 1
Downstream excavation to El. 35 with upstream excavation to El. 31 in preparation for sheet pile cap

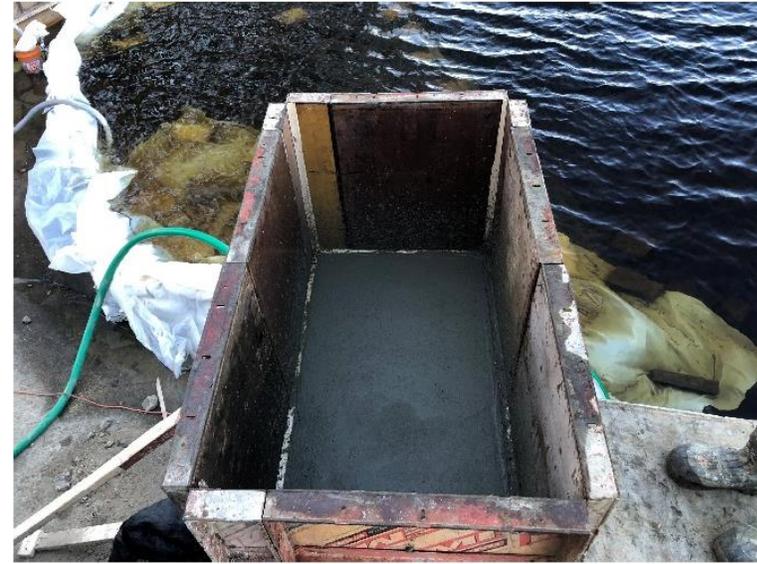
Photo 2
Concrete placement for southern spillway abutment pier

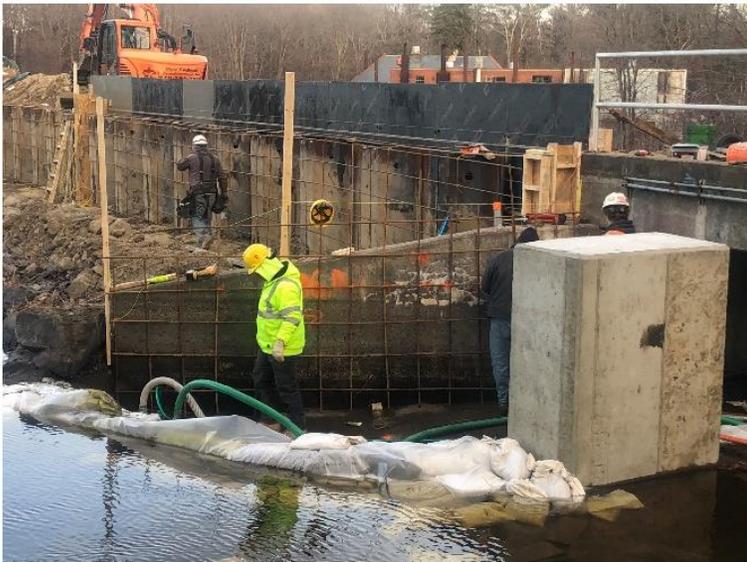
Photo 3
Rebar for northern spillway training wall along with southern spillway abutment pier

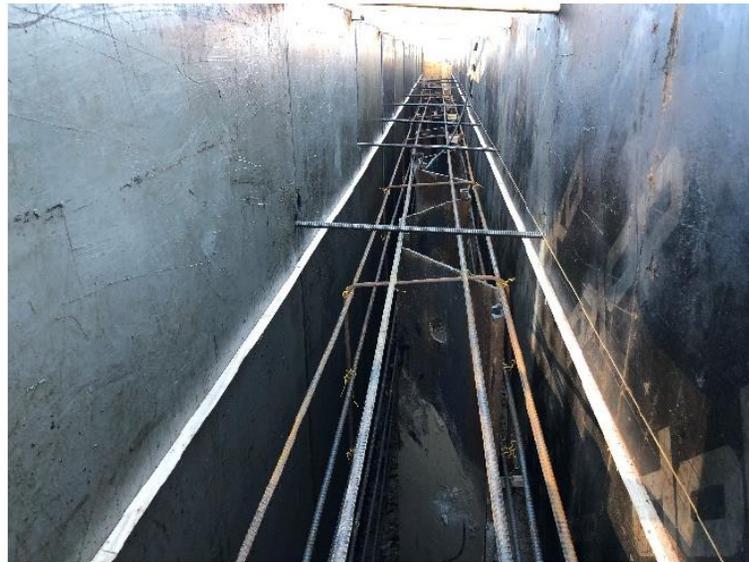
Photo 4
Rebar layout STA 0+00 to STA 0+50 for sheet pile cap
